## Clinical Cases

SET THE VOLUME  
OF BONE AND SOFT TISSUE

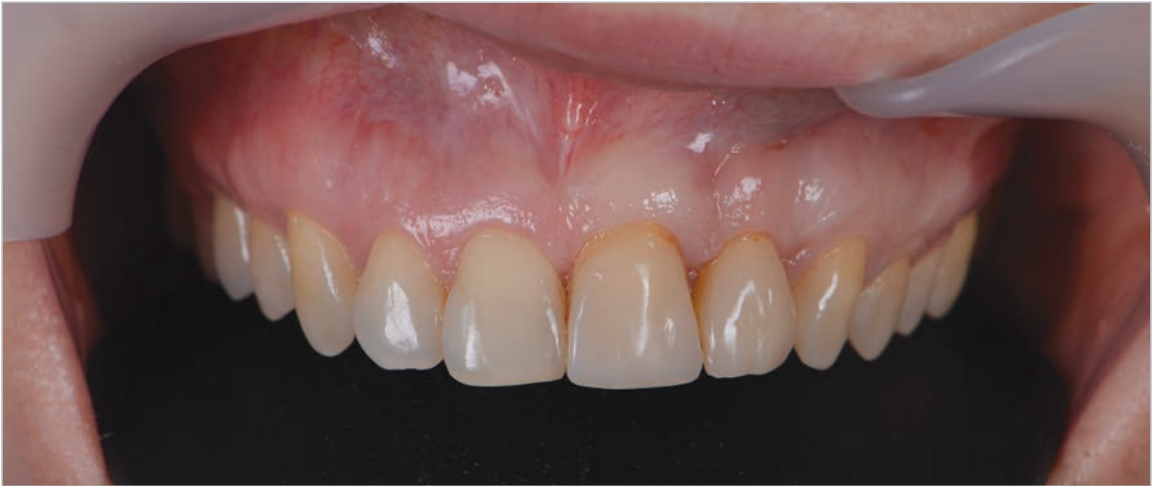
After 3 months, Florin Cofar and Edson Silva finished her case with Zirconia abutment on number 22 and a feldispatic cemented crown on 21, 22 and a ceramic veneer on 23.

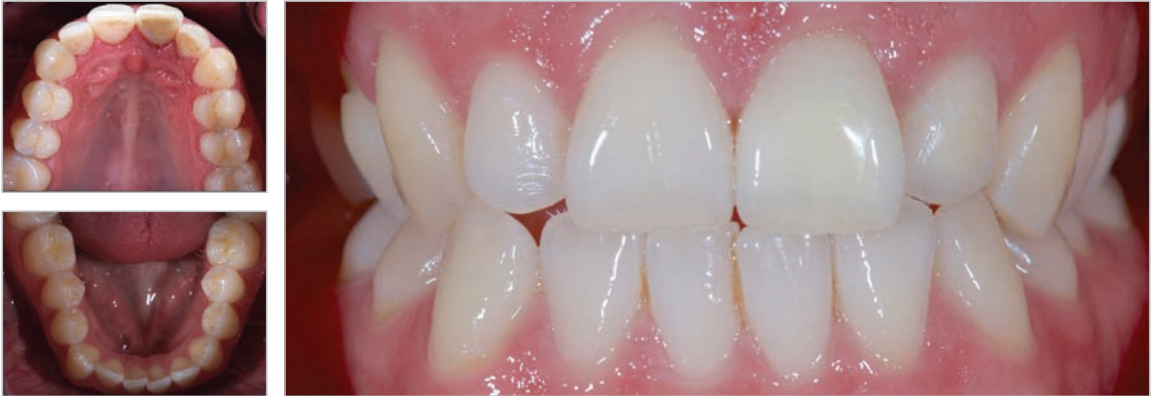
Fig. 1 Pre-operative occlusal and frontal images (January 2015).

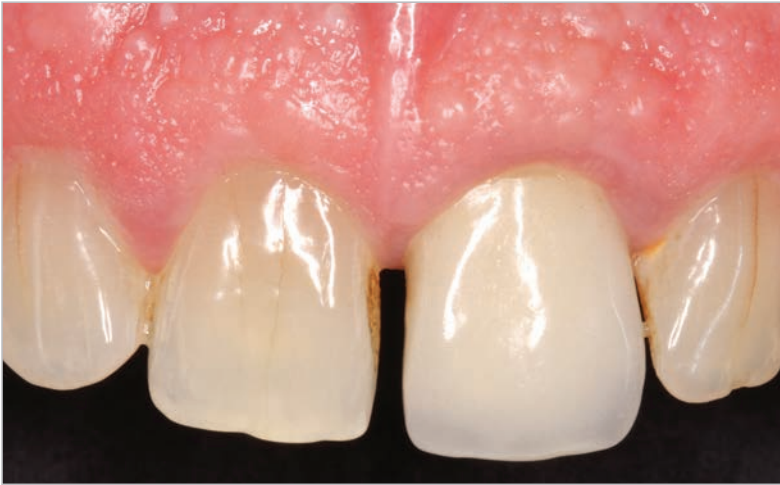
Fig. 1 Prosthetic single crown at site #21 undergoing recurrent decementation.

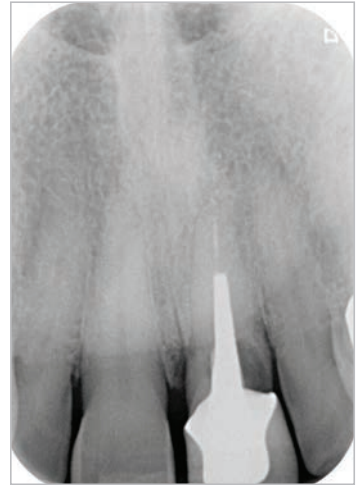
Fig. 2 Radiograph of tooth # 21 showing a loss of radicular integrity.

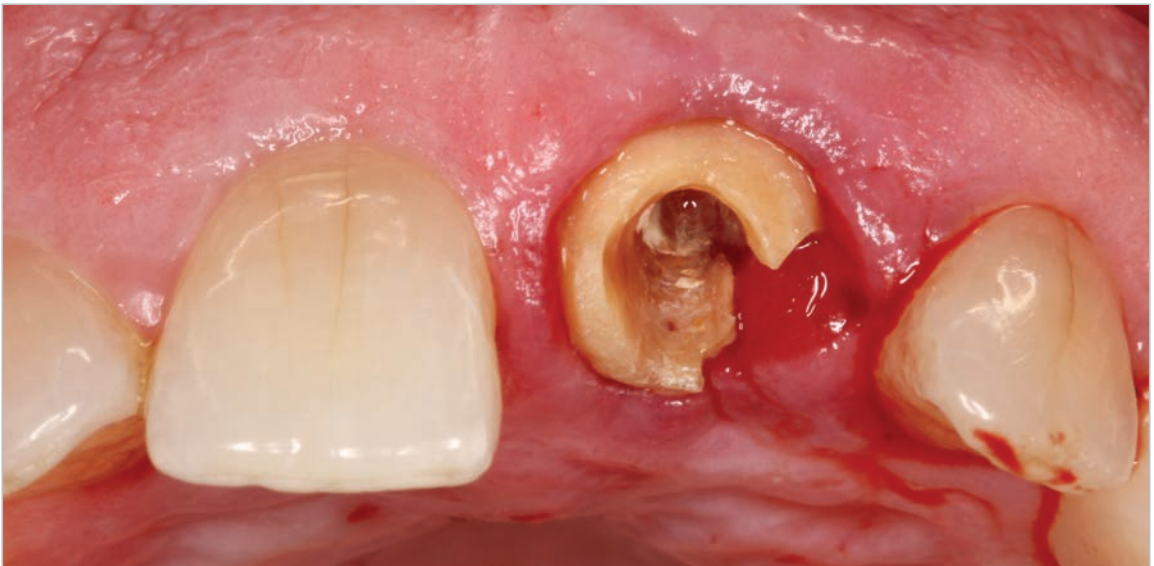
Fig.3 Occlusal view of the decayed root that is unable to provide stability to the prosthetic crown.

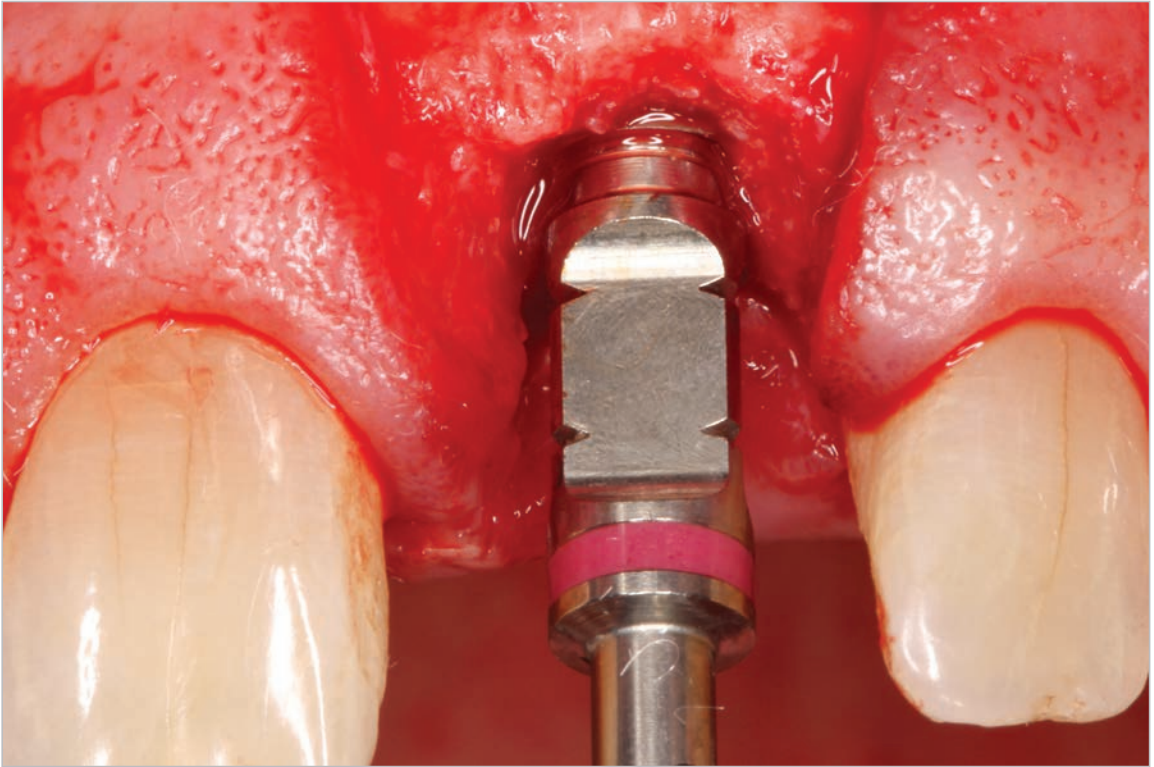
Fig 4 Implant placement of a V3 implant in the preserved crest. The flat part of the neck is parallel to the vestibular cortical lamella as witnessed by the flat part of the implant-holder.

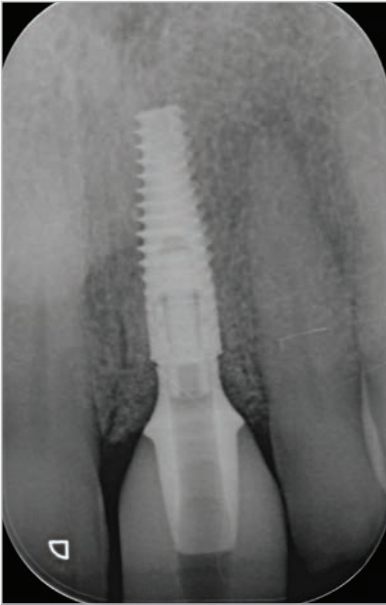
Fig. 8 Radiographic control at final crown placement. Note the bone levels adjacent to the prosthetic abutment.

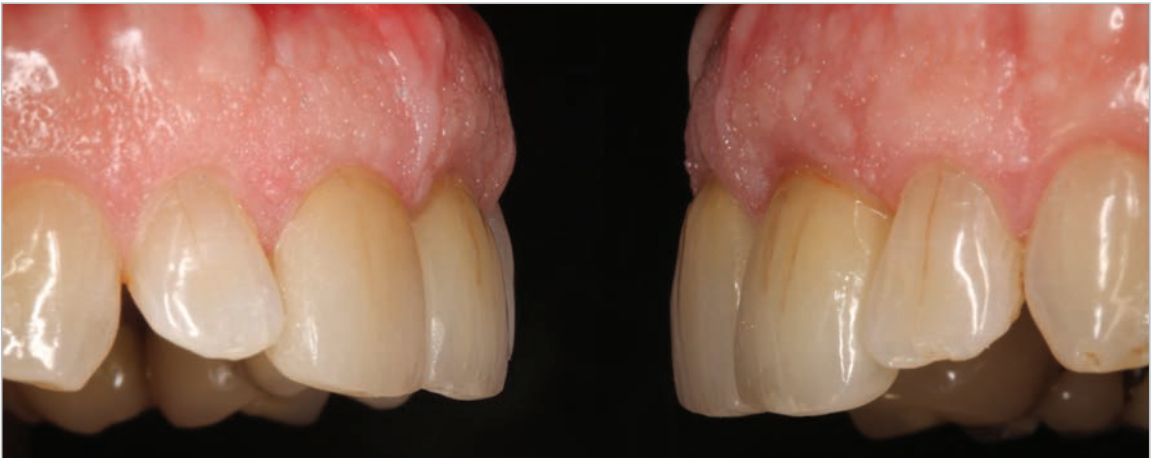
Fig. 9 Left and right lateral views of the esthetic result of the treatment.

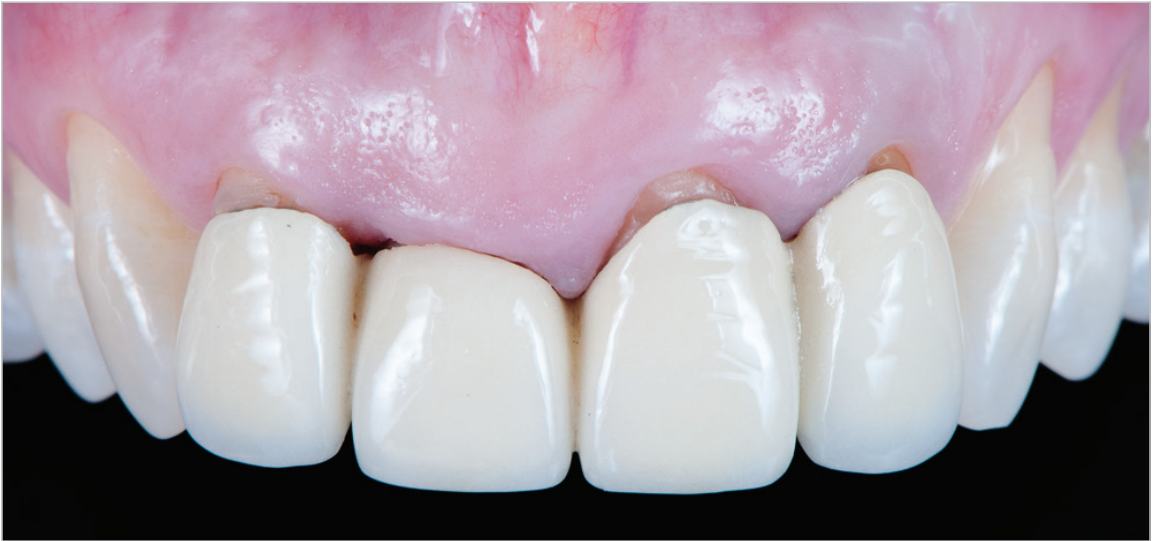
Upon exploration with a periodontal probe, we detected a root fracture obliging us to make the extraction of that tooth. After this finding, the treatment proposed was to change the four anterior crowns and rehabilitate the central incisor with an implant and a soft tissue graft. During healing period we used a four-unit acrylic bridge for the provisional restoration.

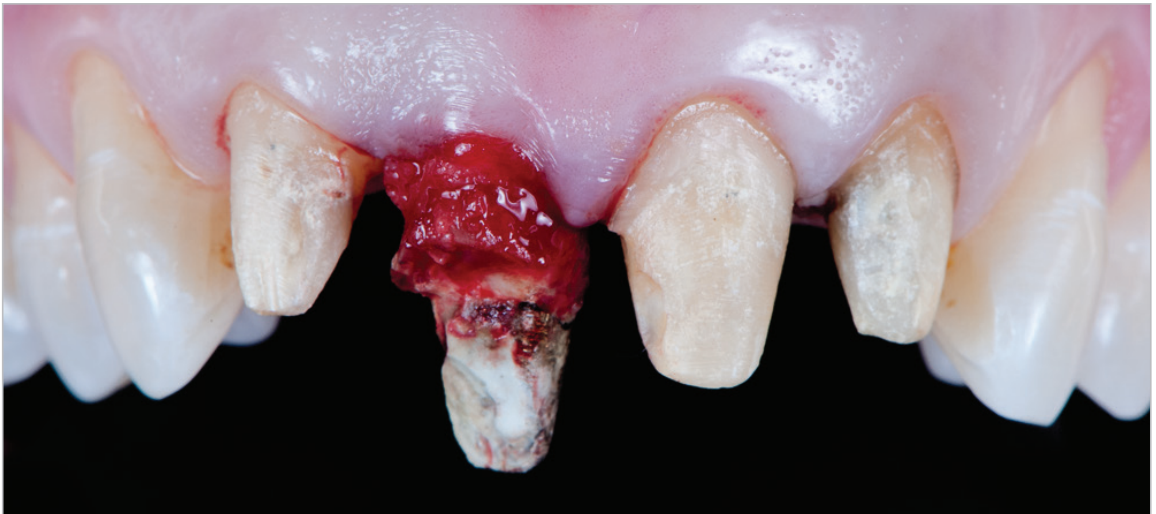
Fig. 4 Fractured tooth extraction.

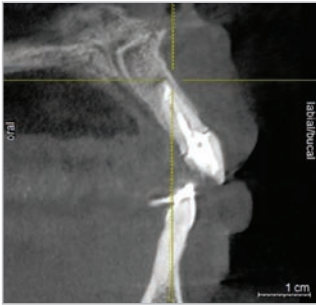
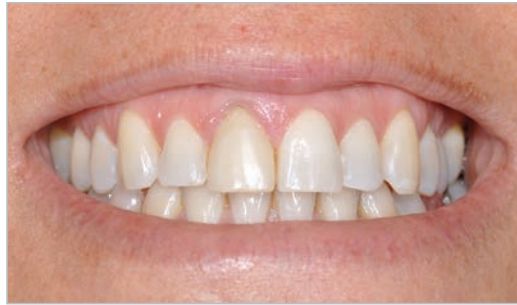
Fig. 1 38 year old patient presents with helpless upper right central incisor.

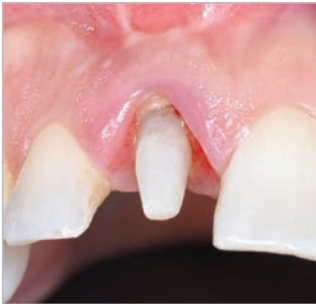
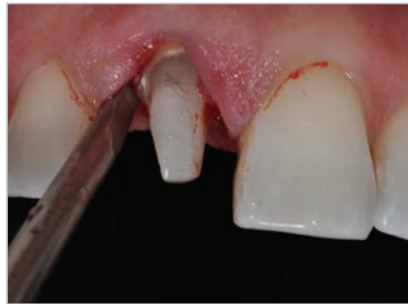
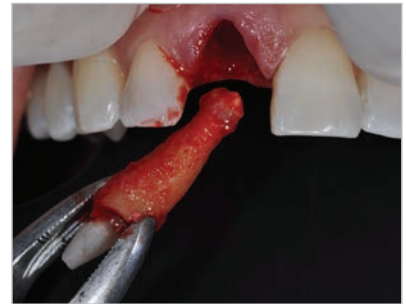
Fig. 2 Atraumatic extraction of 11. Note scarring present as result of the peri-apical surgery previously performed and the periodical lesion at root apex

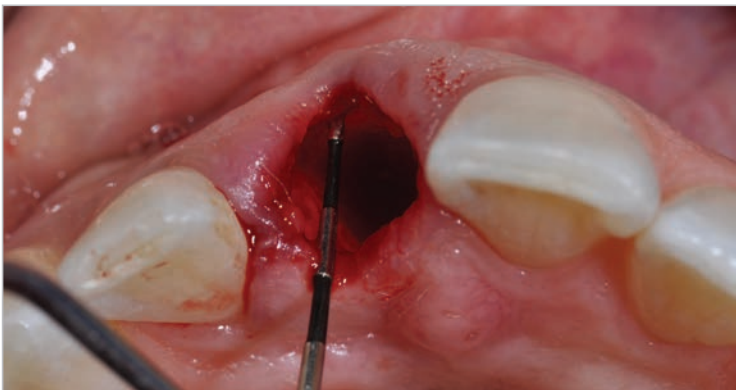
Fig. 3 Favourable buccal bone plate.
