SEM examination and qualitative/quantitative elemental analysis of 65 implant systems – an intermediate report

Surface analysis of sterile-packaged implants

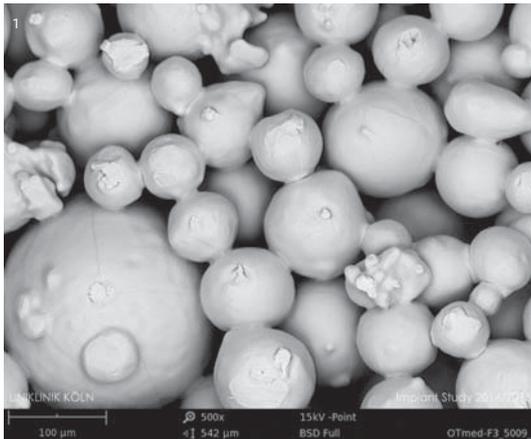
1 | OT-F³ implant, sintered, OT medical (x500).

Surfaces can be shaped by additive or ablative procedures. Additive procedures such as titanium plasma coating are no longer in widespread use. Sintered implant surfaces (Figs. 1 and 2) such as that of the OT-F³ implant (OT medical), where spherical particles are applied to the surface, have the advantage of providing a relatively large surface area. Due to its construction, its design includes no thread.

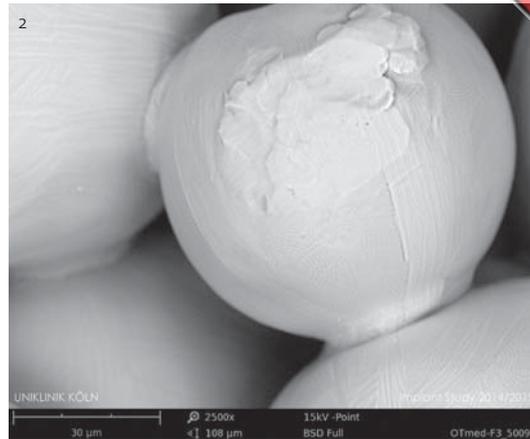
2 | OT-F³ implant, sintered, OT medical (x2,500).

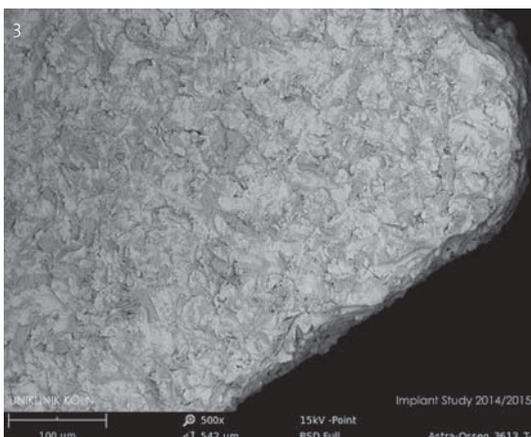
3 | Astra implant, blasted with titanium oxide, Dentsply Implants (x500).

In ablative or subtractive procedures, implants are sometimes only blasted with hydroxylapatite (Zimmer) or titanium oxide (Astra, Dentsply Implants) (Figs. 3 and 4). Alternatively, they are merely etched,

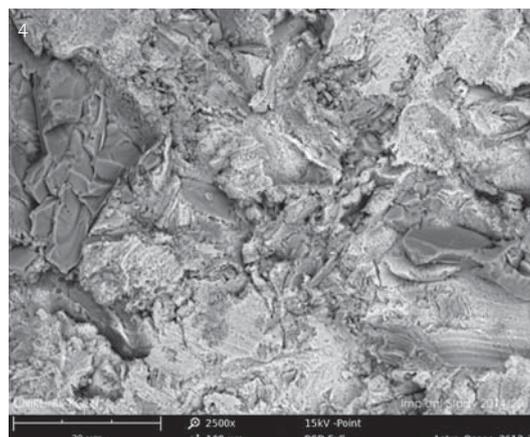
4 | Astra implant, blasted with titanium oxide, Dentsply Implants (x2,500).

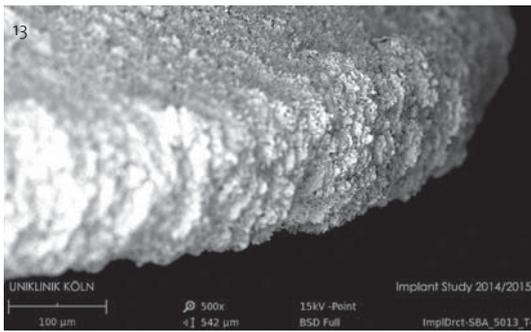
13 | HA-blasted and etched (SBActive) surface with HA coating, Implant Direct (x500).

Implant Direct takes a similar route with its SBActive surface. This surface is blasted with hydroxyapatite, etched and then coated with highly crystalline hydroxyapatite. This coating, which is approximately 10 µm thick, is easy to see in a lateral image of a thread flange (Figs. 13 and 14).

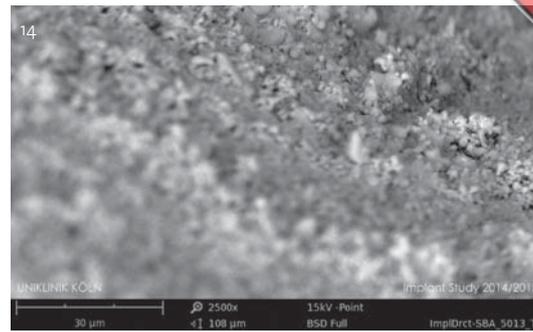
14 | HA-blasted and etched (SBActive) surface with HA coating, Implant Direct (x2,500).

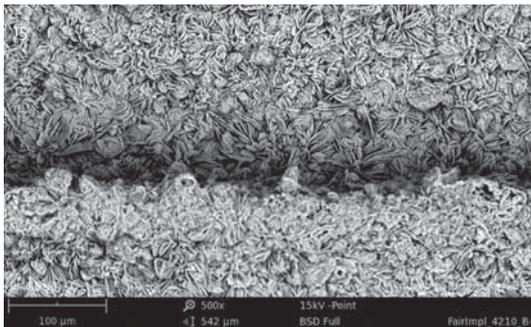
15 | CaP-coated (Bonitex) surface of the FairTwo, Fair Implant (x500).

Schein), in the CP version of the Integra implant (bicon), the Swiss Implant System (SGS Dental) or the FairOne and FairTwo implants (Fair Implant) (Figs. 15 and 16), intend to increase the osteoconductivity of the implants [13].

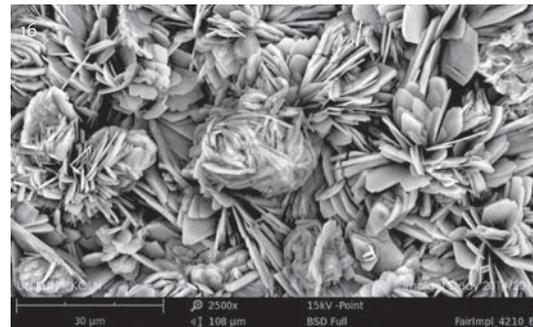
16 | CaP-coated (Bonitex) surface of the FairTwo, Fair Implant (x2,500).

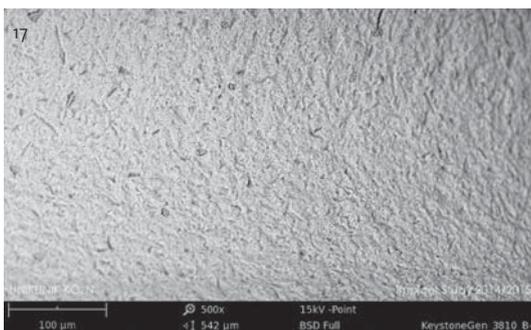
17 | Anodically oxidized (BioSpark) Genesis implant, Keystone (x500).

Anodically oxidized surfaces such as the TiUnite surface by Nobel Biocare or the BioSpark surface of the Keystone Genesis implant (Figs. 17 and 18) exhibit the typical micropores. An additional anodizing layer gives the polished Genesis implant shoulder its characteristic pink shade.

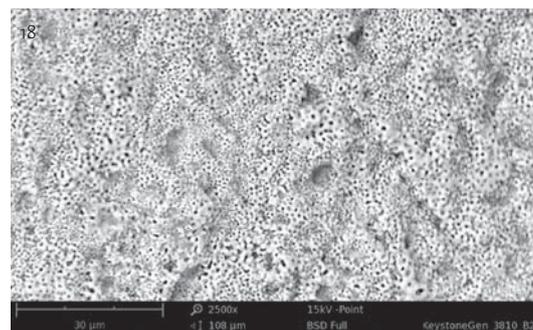
18 | Anodically oxidized (BioSpark) Genesis implant, Keystone (x2,500).

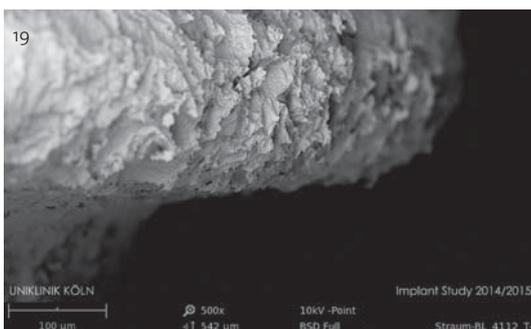
19 | Bone Level implant made of Roxolid with a SLA surface, Straumann (x500).

Roxolid (Straumann) is an alloy of titanium and zirconium whose biomechanical properties are favourable, especially for small-diameter implants (Figs. 19 and 20).

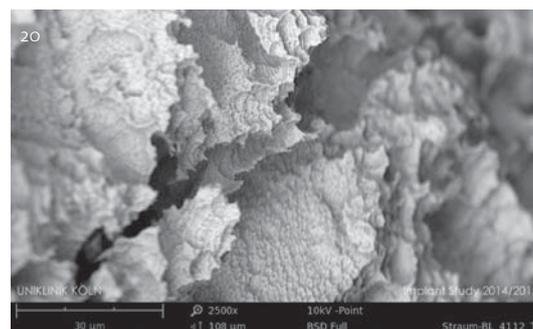
20 | Bone Level implant made of Roxolid with a SLA surface, Straumann (x2,500).

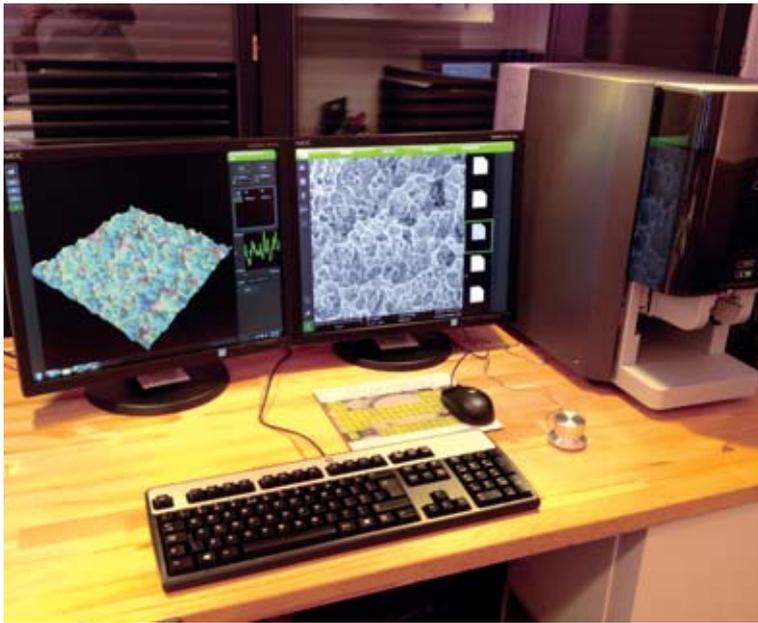
21 | Phenom proX scanning electron microscope.

So far in this study, 65 different implant systems from 37 manufacturers and ten countries have been examined by scanning electron microscopy (Table 1). The SEM instrument used (proX; Phenom, Netherlands) (Fig. 21) facilitates an exact representation of the surface topography and features a highly sensitive detector for backscattered electrons (BSE). This provides a first impression of the composition of the material examined already during the imaging phase (material contrast image), since elements with low atomic numbers (and fewer electrons) such as carbon or aluminium are shown as dark, while elements with higher atomic numbers, such as titanium or zirconium, appear as relatively bright.

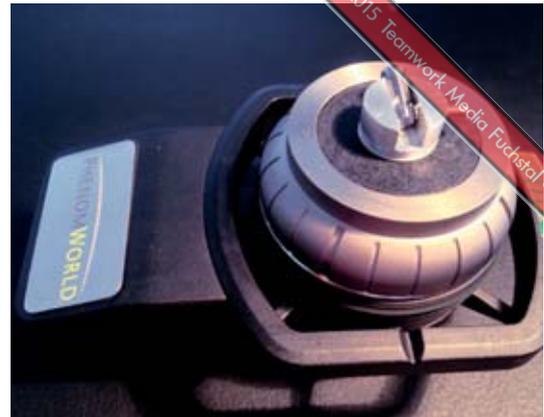
22 | SEM sample unit with mounted implant.

For the examinations, the implants were taken out of their packaging using a sterile forceps and attached to the sample holder (Fig. 22) before being introduced into the vacuum chamber.

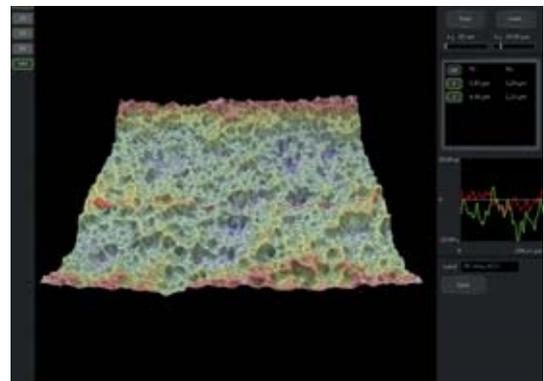
23 | 3D roughness reconstruction of the implant surface (SICmax, SIC).

To document the surface roughness of each of the investigated implant systems, a so-called 3D roughness reconstruction was additionally performed that allows a visual comparison of the respective surface structures. Here, the three-dimensional shape of the object is calculated from the brightness distribution in the grid of the four quadrants of the backscattered electron detector. Using this shape-from-shading technology, implant-typical surface geometries can be represented spatially (Fig. 23).

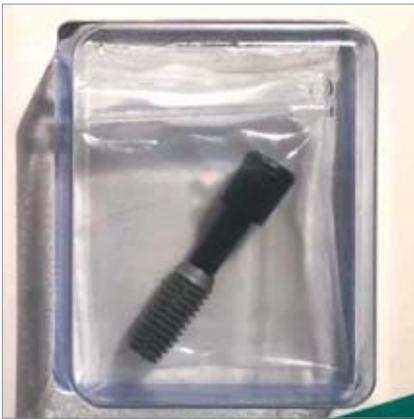
24 | Simple sterile packaging (LDPE zip lock bag) in a blister.

As in the 2008/2009 study, the Integra implant (bicon), whose inner sterile packaging still consists of a simple zip lock bag made of soft polyethylene (LDPE) (Fig. 24), showed again organic residue. This systematic residue, which is not limited to isolated spots, was predominantly found near the outer edges of the parallel threads (Figs. 25 and 26) and may originate from direct contact with the packaging.

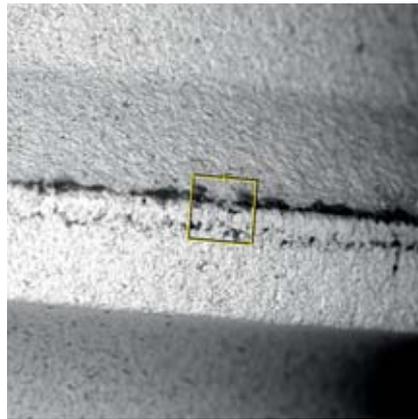
25 | Conspicuous organic residue on the external surface (Field of View).

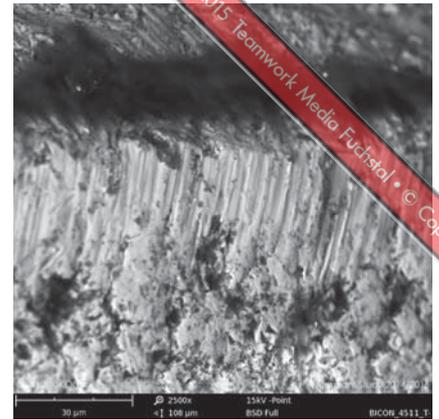
26 | Organic residue, Integra, bicon (x2,500).

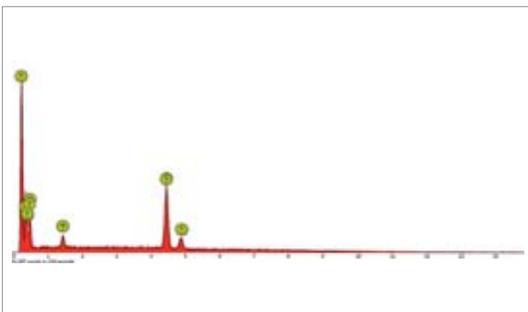
27 | Qualitative elemental analysis.

The qualitative elemental analysis shows not only the peaks typical of grade 5 titanium (Ti-6Al-4V) for titanium, aluminium and vanadium but also a clear peak for carbon (Fig. 27), which was confirmed by the quantitative analysis (Table 2). The calcium phosphate-coated version of this same implant had not exhibited organic contamination in the 2011/2012 study despite using the same packaging, possibly because of the lower surface roughness of the implant.

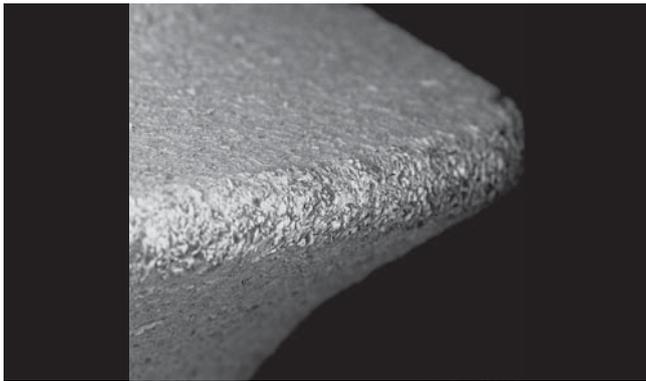
28 | Lower thread structure, QK implant, Trinon (x500).

A different factor must have been responsible for the organic residue on the QK implant (Trinon, Germany) (Figs. 28 to 30, Table 3), as there is no contact with the packaging and the organic residue is not limited to the outer edges of the thread. The same implant shows smaller particles that already stand out in the material contrast image due to their bright grey tone. The elemental analysis detected iron, copper and chromium (Figs. 31 to 35, Tables 4 and 5). No similar clusters of these metal particles, approximately 3 µm in size, were found in any of the implants investigated so far in this study. As for the organic contaminants, one can only speculate

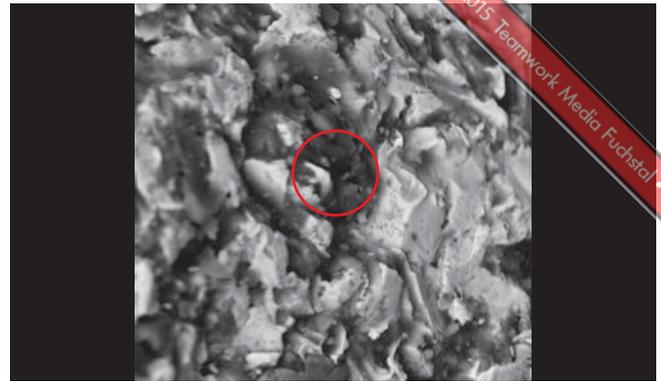
29 | Thread structure, QK implant, Trinon (x5,000).

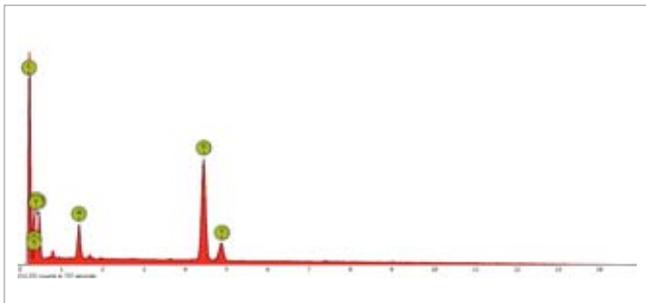
30 | EDX spectrum (qualitative elemental analysis), marked area, QK implant, Trinon.

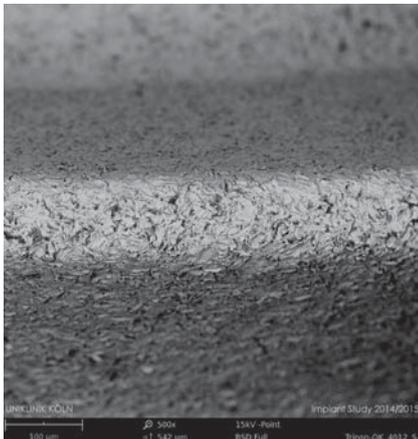
31 | Upper thread, QK implant, Trinon (x500).

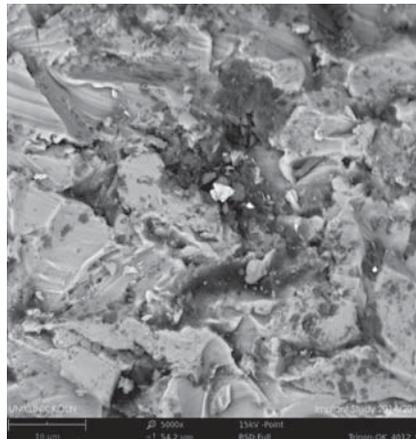
32 | Upper thread, QK implant, Trinon (x5,000).

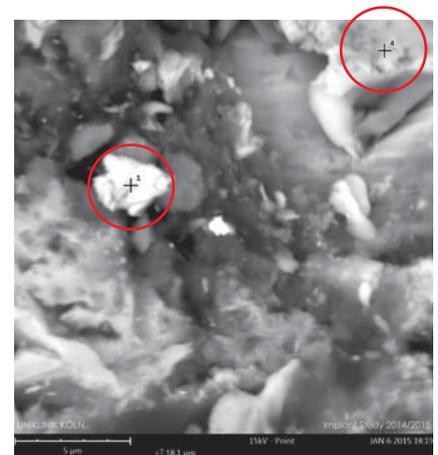
33 | Detail image (x10,000) for EDX spot analysis (left: metal particles, right: control).

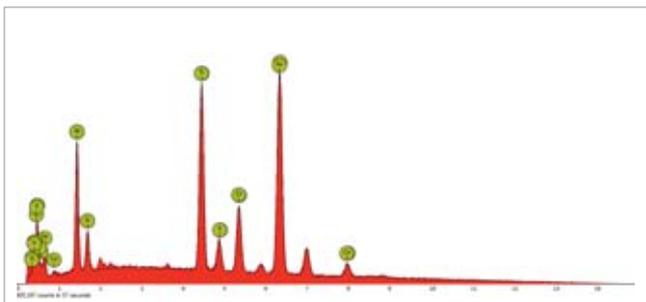
34 | EDX spectrum, spot #1 (metal particles).

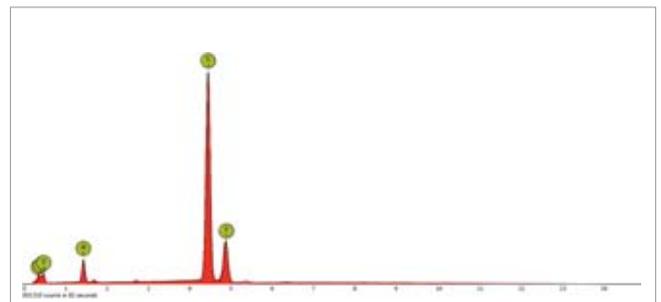
35 | EDX spectrum, spot #4 (control).

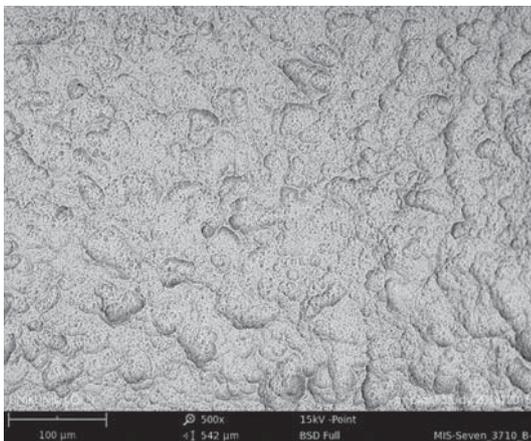
36 | Residue-free surface, MIS Seven implant (x500).

The C1 implant and the Seven implant (both MIS) stood out positively in the current study. Whereas during the 2011/2012 study, the Seven implant still exhibited blasting material on up to seven per cent of the surface, the current study did not even find isolated spots with residue on the two MIS implant types of grade 23 titanium (Ti 6Al-4V ELI) (Figs. 36 to 38, Table 6). Another positive surprise was the TRI-Vent Implant (TRI), which in the current study had a very precise external geometry (Fig. 39).

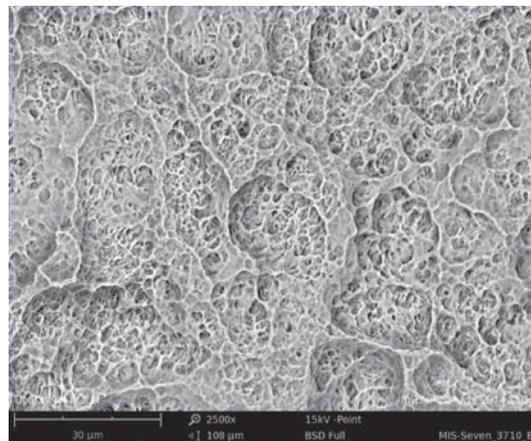
37 | MIS Seven implant surface with micro-nano-structure (x2,500).

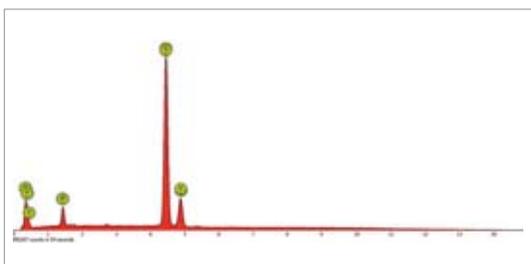
38 | Inconspicuous EDX spectrum of the MIS Seven surface (areal analysis).

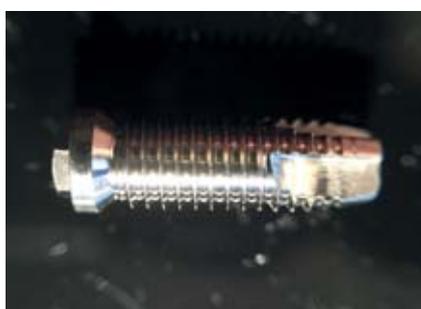
Machined SurfLink dental implant.

The machined SurfLink dental implant appeared inconspicuous at first (left). Unlike the original machined implants (MK III, Nobel Biocare), now available from the manufacturer only on special request, the surface of this implant has been treated with a covalently bound biomimetic monolayer, which due to its thickness of only about 1 nm cannot be detected by conventional SEM or EDX. Thus, this surface treatment is fundamentally different from the much thicker calcium phosphate coating. The monolayer presents osteoblasts with phosphorous-rich groups bound to the implant, mimicking natural hydroxyapatite [14]. The difference can be seen in machined implants retrieved from animals in an experimental study of the University of Zürich 52 weeks after insertion [15]. The SEM showed little adherent bone in the control group at the same magnification after removal of the implant (removal torque test) (centre), whereas the treated implants exhibited broad bone apposition on the smooth implant surface (right). The SurfLink treatment (Nano Bridging Molecules, Switzerland) can be applied at chairside to virtually all titanium and zirconia implant surfaces.

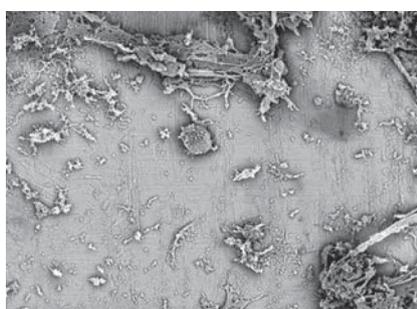
Bone growth on untreated (control) implant (x2,500).

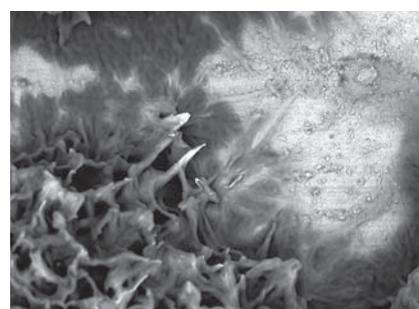
Bone growth on implant with a biomimetic monolayer (x2,500).

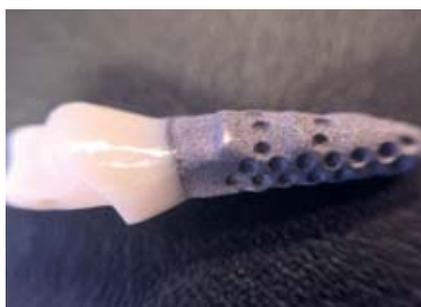
Custom-made root-analogue Replicate implant, Natural Dental Implants.

The custom-made root-analogue Replicate implant (Natural Dental Implants, Berlin) plays a special role in this study. Unlike rotationally symmetric implants, it is fabricated individually based on digital reconstruction data acquired before extracting a hopeless tooth. After taking a CBCT, standard impressions are taken of both jaws and a bite registration is made. The impression is digitized in the micro-CT, synchronized with the CBCT data, and the tooth is reconstructed digitally from apex to crown. The digital model is segmented exactly at the site of contact with an appropriately shaped zirconia abutment. The root is milled from grade 4 titanium according to the recorded data, and its surface is sandblasted and acid-etched. The zirconia abutment and the root-shaped titanium implant are connected with solder glass (left). The SEM images show the different materials, titanium (centre) and zirconia (right).

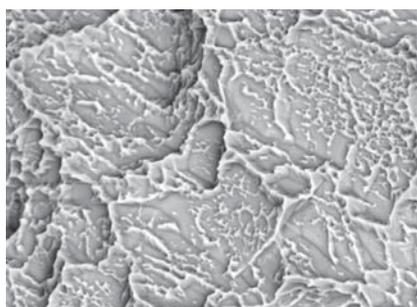
Root aspect made of titanium without processing residues (x5,000).

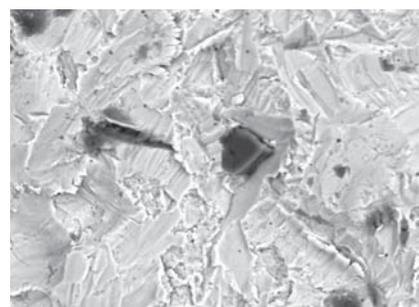
Aspect of a zirconia abutment roughened prior to inserting the crown (x5,000).
